# The Impact of Landslides in Reclamation Areas from Stone Crusher Production Residue Materials in the Tsunami Event in the Sulawesi Earthquake on September 28, 2018

**ABSTRACT:** Sulawesi earthquake disaster followed by a tsunami on September 28, 2018 still leaves several big questions, namely the type of normal strike slip fault that rarely causes a tsunami, the very short tsunami arrival time of around 2-5 minutes and the bay area that should rarely be hit by a tsunami. Several previous studies have provided several hypotheses that the tsunami was caused by an underwater landslide or vertical deflection of the seabed due to the super shear movement. This study conducted a study of the impact of Stone Crusher factories residual production based on a field survey and supported by secondary data from previous researchers on the tsunami disaster after the strong earthquakes. The results of the field survey showed an area of around 40 Ha that collapsed on the surface, most of which was a pile area of residual Stone Crusher production on the West coast of Palu Bay. This area stretches around 20 km covering the areas of Palu City and Donggala Regency. Based on the data, there are arou

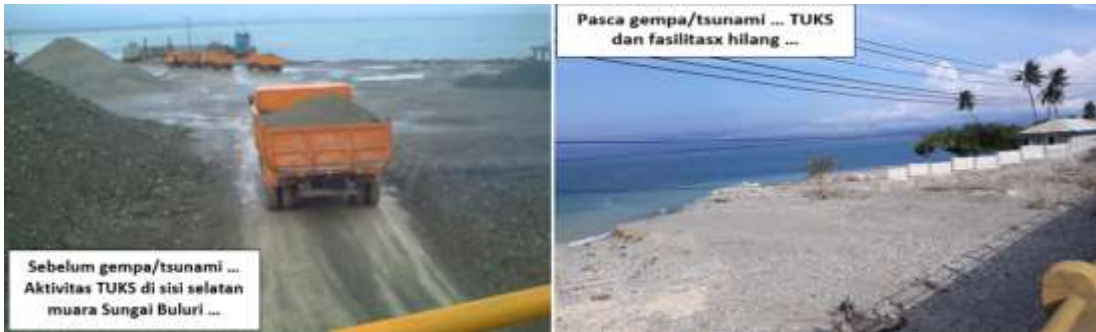
Fig.2 Stone Crusher Factory Activity in Buluri Subdistrict, before (Left) and after (Right) [11]

Figure 1 shows the research location, which is on the West side of Palu Bay. The slope conditions in Palu Bay are also presented in the figure. The steeper slope of the West side than the East side causes the potential for underwater landslides due to embankments or natural cliff landslides to be more dominant on the West side. Figure 2 shows the loading activity of the stone crusher factory's production in the form of sand and split which will be sent to the Provinces of East Kalimantan and North Kalimantan on the island of Kalimantan. There are at least 11 jetty locations like this. After the earthquake accompanied by a tsunami, the condition of the shipping location like this was damaged and some of the land was lost, collapsing into the seabed. After the earthquake and tsunami, most of the jetty facilities have been

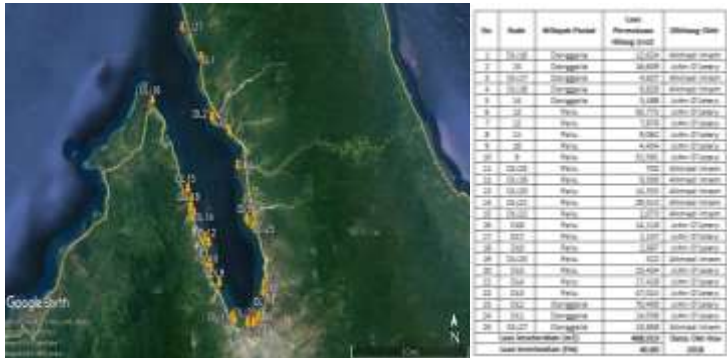
Fig.3 Map and table of land area lost after the Palu-Donggala earthquake on September 28, 2018 [11]

repaired and the loading process of stone crusher production materials has resumed. Figure 3 shows a map and table of the area of land lost after the earthquake and tsunami around Palu Bay. At the research location around the C mining factory, there are 7 points with an area of about 7 Ha where the land was lost to the seabed. The total area of land lost around Palu Bay after the earthquake and tsunami is around 40 Ha. Of the vast area of land that has been lost to the seabed, there are residential areas, public facilities such as mosques, tourist attractions and several other infrastructure facilities on top of it. In Figure 4. Also presented are satellite images around the Palu Bay area in the form of conditions before and after the tsunami hit the coast of Palu Bay. The condition of the embankment that has not been properly consolidated causes

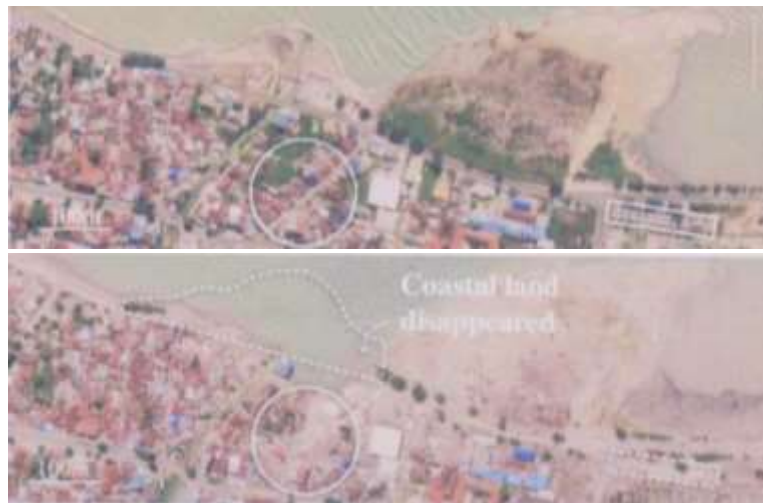
the embankment on the coast to be easily lost, either due to the tsunami or landslides to the seabed. At the time of the disaster, temporary loading activities were taking place, so that many people became victims buried along with facilities such as office buildings, loading ships and container ships. Figure 5. shows the condition of the bottom of Palu Bay before and after the earthquake accompanied by a tsunami. The red color on the west side of Palu Bay is an indication of shallowing of the bay floor, which indicates a landslide of material on the edge of the beach. In Figure 6. Shows an aerial photo shortly after the earthquake, the presence of 5-7 whirlpools at several locations indicates that landslides occurred simultaneously at these points. As an area crossed

**Fig.5 Coastal conditions in Palu Bay before and after the tsunami and landslide graphics (Reuter Graphic, 2018)**

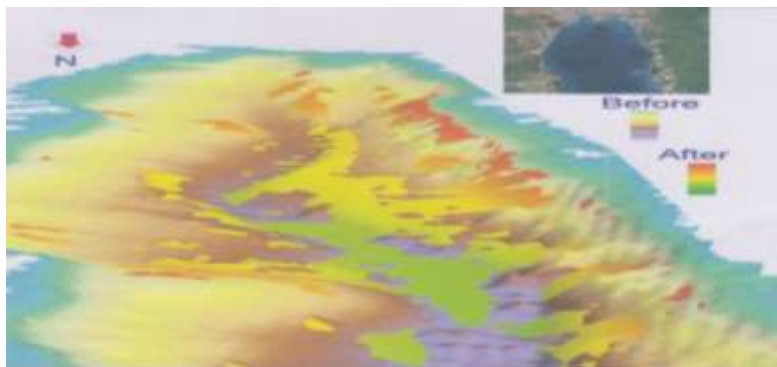
**Fig.6 The depth of the bottom of Palu Bay before and after the earthquake (red color is shallowing due to landslides) [7]**

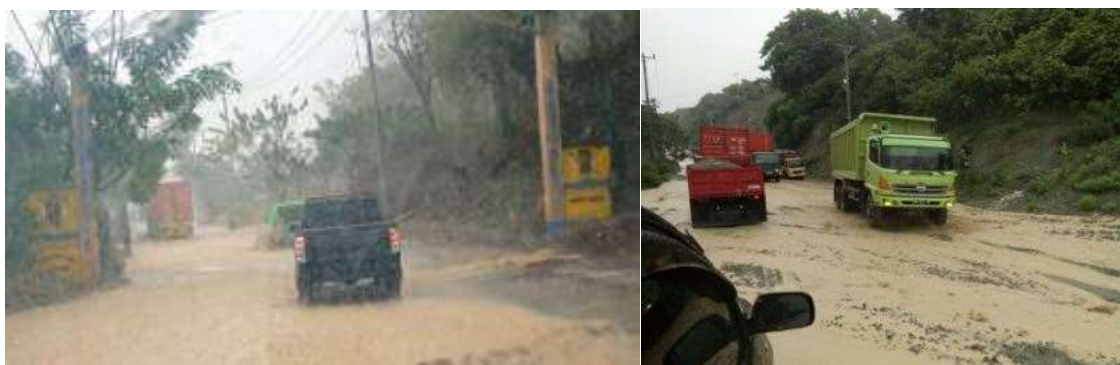
**Fig.7 Condition of the Palu-Donggala road during the rainy season**

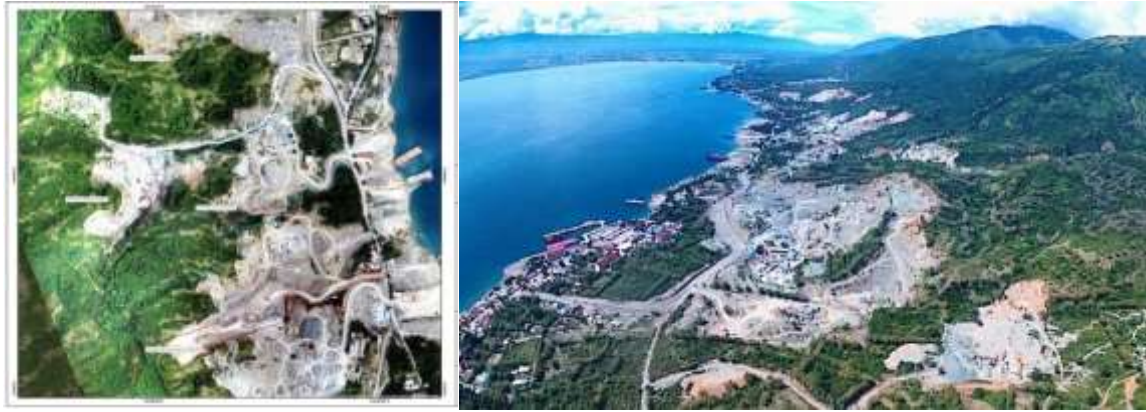
**Fig.8 Aerial photo of the condition of the C-type mining area on the west side of Palu Bay on the Palu-Donggala road section [10]**
