## Evaluation of Pavement Condition and Remaining Service Life on the Guru Tua Road Section

**ABSTRACT:** The Guru Tua Road Section is a provincial road with a length of 3.96 km, serving as a connecting infrastructure between Sigi Regency and Palu City. Pavement conditions at several points are experiencing damage and causing uncertainty regarding the estimated remaining service life. This research aims to determine the condition of the road pavement to specify the type of handling, and to analyze the road's remaining service life. The evaluation of the functional condition of the road uses the International Roughness Index (IRI), Present Serviceability Index (PSI), and Surface Distress Index (SDI) methods, while the analysis of the remaining service life uses the AASHTO 1993 method. The research results indicate that the pavement condition of the Guru Tua Road Section is considered moderate, with an average IRI value of 4.595. Meanwhile, the average service function of the road is poor, with a PSI (Equation I) value of 1.205 and a PSI (Equation II) value of 1.232. Furthermore, the road pavement condition based on the average SDI value of 27.875 is good. The results of the remaini

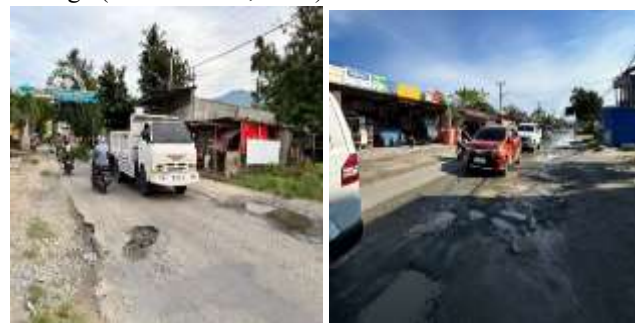
**Figure 1. Pavement Deterioration on the Guru Tua Road Section**

Based on preliminary field surveys, pavement conditions at several locations along this road section have experienced various forms of damage, as illustrated in Figure 1. These conditions potentially pose safety risks to road users; therefore, a comprehensive analysis of pavement conditions is required to determine appropriate and sustainable maintenance strategies. Road condition assessment should be conducted periodically, considering both structural and functional aspects. The resulting pavement condition values serve as the basis for determining suitable treatment measures, whether in the form of routine maintenance, periodic maintenance, or upgrading/reconstruction.

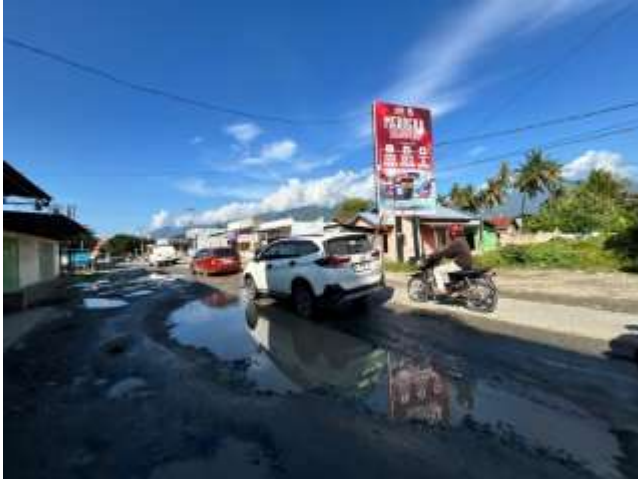
The pavement condition analysis based on IRI values shows varying conditions, with 14 segments classified as good, 23 segments as fair, 2 segments as lightly distressed, and 1 segment as severely distressed. The severely distressed segment, identified by very high IRI values between STA 02+300 and STA 02+400, indicates significant discomfort and potential hazards for road users. The severely distressed pavement condition is illustrated in Figure 5.

Figure 5. Severe Distress Condition at STA 02+300 – STA 02+400

| STA | IRI 2025 | SDI 2025 | Road Condition | Maintenance |
|---|---|---|---|---|
| 02+300-02+400 | 12,439 | 85 | Severe Damage | Reconstruction |
