Are There Any Correlations Between the Functional and Structural Performance of Indonesian National Road Conditions?

ABSTRACT: The deterioration of road conditions affects the safety and comfort of road users. The initial stage of implementing road rehabilitation and maintenance management involves conducting an inventory through routine assessments of pavement functional and structural conditions. Evaluating functional and structural conditions is essential for determining the appropriate rehabilitation and maintenance methods. However, evaluations are typically focused only on functional conditions. Therefore, it is necessary to investigate whether a relationship exists between the functional and structural conditions of roads to determine their correlation. This study aims to evaluate the functional and structural conditions of three national road sections: the Simpang Tiga East Ring Road – Pati/Kudus District Boundary, Lingkar Pati, and Wangon – Menganti. The functional conditions were assessed using the Hawkeye 2000 vehicle, which generates Pavement Condition Index (PCI) data for each road segment, providing the average PCI value and the condition of each segment. Meanwhile,

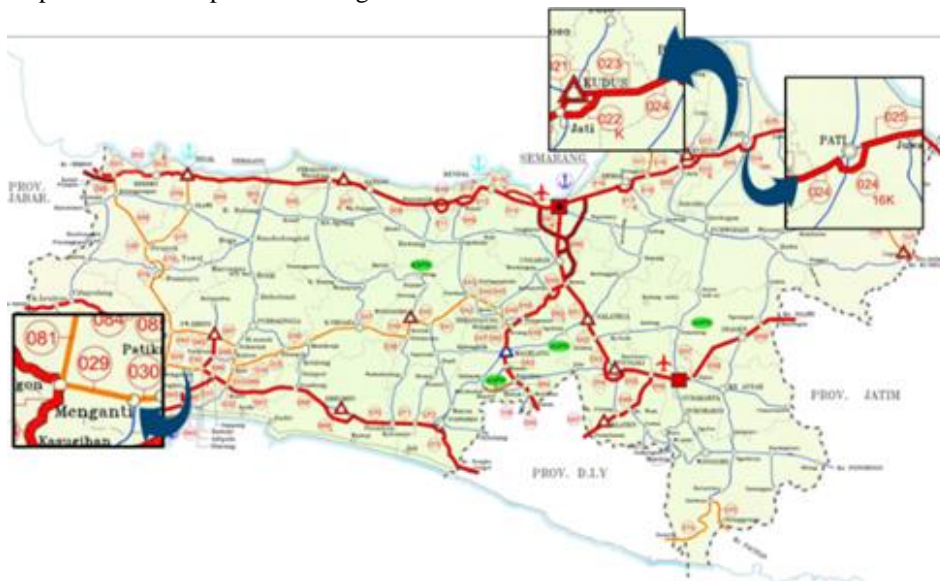
Figure 1. Location and Road Network Map

Lingkar Pati, and Wangon – Menganti sections. The location and road network are depicted in the map shown in Figure 1.

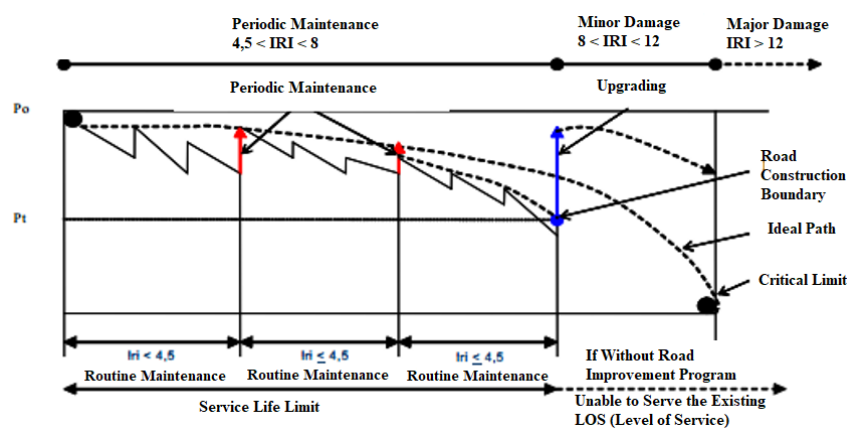
Figure 2. Relationship between condition, age and type of road service [2]

Highways are transportation infrastructure whose structural value decreases over time, as illustrated in Figure 1. When the road is completed and ready for operation, the pavement index value is at its highest level (P_0). Due to traffic operations, the pavement index value gradually declines over time, following the planned curve, until it reaches a certain point at a specific service period limit (t), or the P_t value. At this point, the road can no longer adequately serve traffic or has reached its construction limit. In this condition, treatment

in the form of road improvements is required to restore it to its original service level (P_0).

P_0 : Initial Serviceability Index

P_t : Terminal serviceability index

P_0 dan P_t values are highly dependent on road classification and ADT

However, to ensure that road conditions align with the initial scenario—following the planned curve to the construction boundary—regular maintenance is essential. Maintenance activities are necessary to enable the road to provide the planned level of service. Without maintenance, the road will not reach its intended service life and may experience accelerated damage [1].

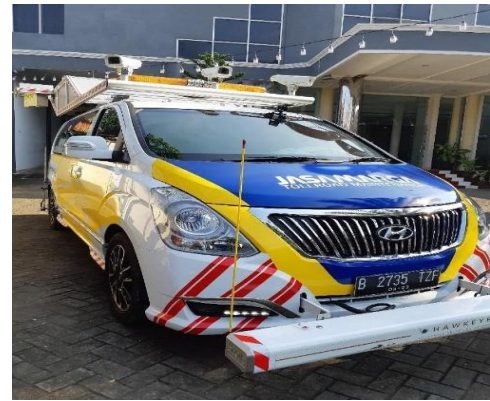
Figure 4. Hawkeye 2000 Vehicle

The PCI value ranges from 0 to 100, with criteria such as perfect, very good, good, fair, poor, very bad, and failed [5]. The PCI rating range follows ASTM D 6433-18 [7], as shown in Figure 3. PCI calculations are based on visual surveys of road conditions, identifying the type, severity, and quantity of damage. The PCI data collection uses the Hawkeye 2000 vehicle, shown in Figure 4, which is an integrated, modular, and scalable digital highway survey tool designed for road condition assessments. The Hawkeye 2000, developed by the Australian Road Research Board (ARRB), provides road condition values such as the International Roughness Index (IRI) and Surface Distress Index (SDI). Using the Hawkeye 2000 ensures data that is well-scaled and meets established standards.

This research aims to evaluate the functional and structural conditions of three national road sections: the East Ring Road Simpang Tiga – Pati/Kudus Regency Border, Lingkar Pati, and Wangon – Menganti. The functional condition was tested using a Hawkeye 2000 vehicle, which generates Pavement Condition Index (PCI) data for each road section, providing average PCI values and overall road condition assessments. Meanwhile, the Falling Weight Deflectometer (FWD) tool was used to produce deflection data, which was subsequently utilized to calculate representative deflection values (D represented) and elastic modulus (E).

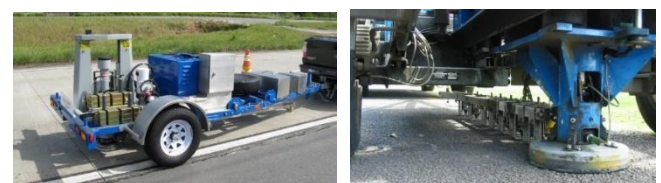
Figure 5. Falling Weight Deflectometer tools

The Falling Weight Deflectometer (FWD) is a device used to evaluate the stiffness of pavement and its layers. It is a trailer-mounted apparatus that operates by dropping a load onto the pavement and measuring the resulting deflection. The residual strength of the pavement is determined by analyzing the deflection caused by the load and the traffic load. The FWD is specifically designed to assess the structural performance of flexible pavements without causing damage to the road pavement construction.

The working principle of the FWD involves applying an impulse load to the flexible pavement through a round plate, simulating the effect of a vehicle. Figures 5 and 6 provide a representation of the Falling Weight Deflectometer tool.

Stages of Deflection Testing with FWD Tools. The stages of deflection testing on flexible pavement using the FWD tool are as follows:

- A load of 41 kN is used for testing on flexible pavement.
- A minimum of two load drops is required. The first load drop is used as an 'adjustment' to properly position the loading plate on the surface.
