## Evaluation of the Production and Quality of Comex Engine Overhaul with 4M1E Method at PT. CA3-Indonesia

**ABSTRACT:** This study aims to evaluate the production process and overhaul quality of Comex engines at PT. CA3 throughout 2024. The evaluation applies the 4M1E method and fishbone diagram analysis to identify the root causes behind the low production achievement and high rate of rework (redo). The results show that only 79 engines were overhauled out of the annual target of 179 units (46%), with 14 recorded redo cases, representing 17.7% of the total output. The main contributing factors include insufficient technician competence, inconsistent implementation of SOP and QA procedures, the use of non-genuine components due to spare part shortages, uncalibrated measuring tools, and suboptimal working conditions. Based on these findings, strategic recommendations are proposed, including technician training improvements, the addition of senior-level personnel, implementation of internal audits, and enhancements to the QA system and work environment. This study is expected to serve as a reference for improving the efficiency and quality of engine overhaul processes at PT. CA3.

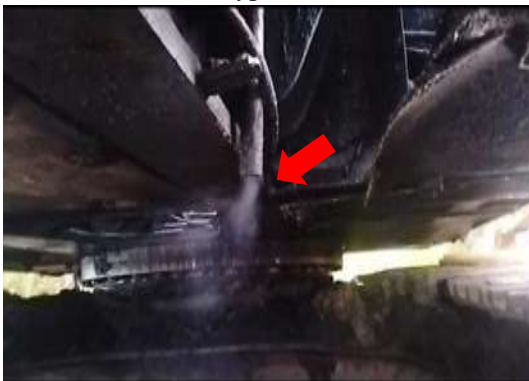
Figure 4. Engine high blowby.

This issue was caused by combustion gas compression leaking into the crankcase, typically due to worn piston rings, imprecise cylinder liners, or improper assembly. The occurrence of three cases early in the year suggests a possible failure in final inspection or errors during the assembly process.

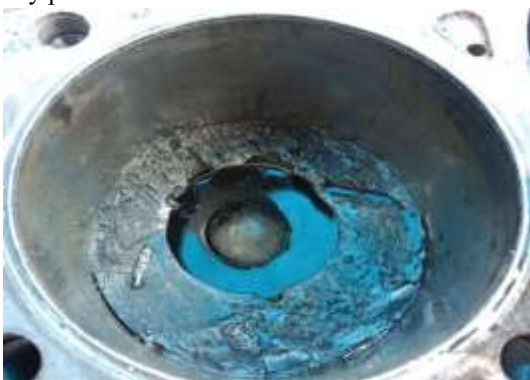
Figure 5. Piston jammed.

This indicates severe mechanical damage such as seized pistons, bent connecting rods, or damaged bearings. Such failures may result from inadequate cleaning processes, insufficient pre-lubrication, or components that do not meet standard tolerance specifications.

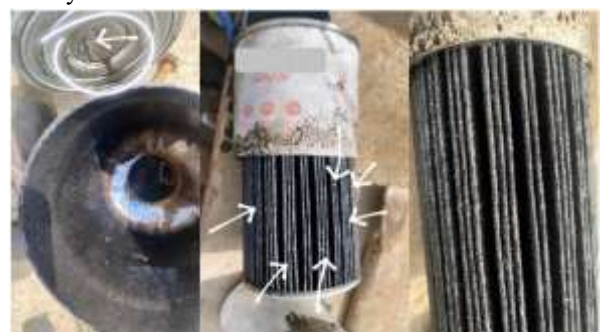
Figure 7. Fragments of material.

Metal particles (metal shavings) were found in the filter or oil pan, indicating contamination during the assembly process or inadequate cleaning of components. This issue may also be related to insufficient cleanliness control in the work area.

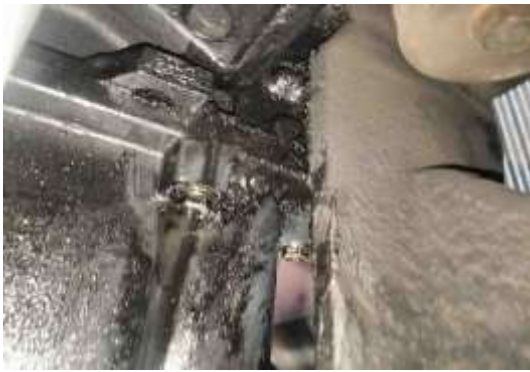
**Figure 8. Oil seal leak (Engine Leaking).**

Leaks can occur due to improperly installed seals, damaged gaskets, or cracks in the housing. One such case occurred in a compactor unit, indicating the need for a thorough reinspection of the sealing system and fluid leakage.

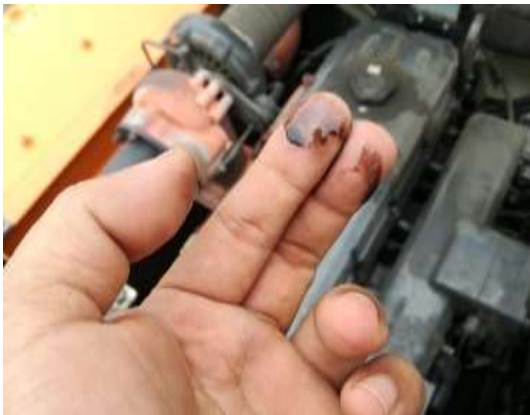
**Figure 9. Oil mix fuel.**

This is a serious issue where lubricant mixes with fuel, which can be caused by leaking injector seals or failure of the fuel pump. This problem typically arises due to initial misdiagnosis or incorrect seal installation.

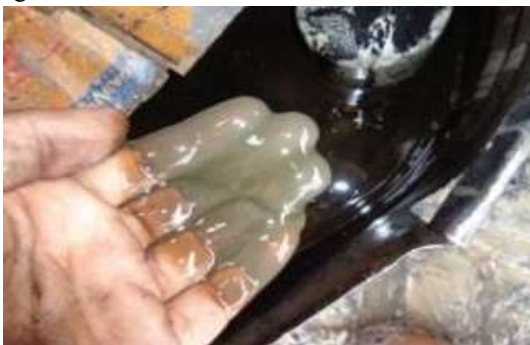
**Figure 10. Oil mix coolant.**

The mixture of oil and coolant can be caused by leaks in the oil cooler, cracks in the cylinder head, or a faulty head gasket. This indicates a problem in the separation system between the lubricant and the coolant.

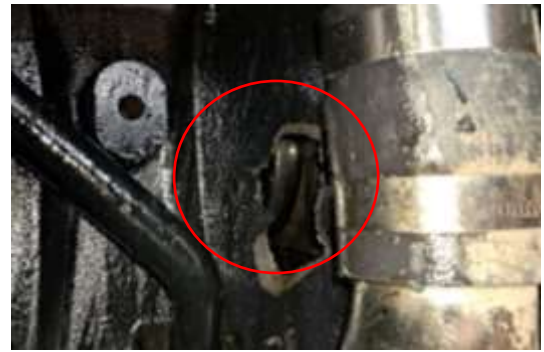
**Figure 11. Cylinder block damage.**

Damage to the cylinder block can be caused by incorrect torque during installation, undetected wear during inspection, or material defects that passed inspection.

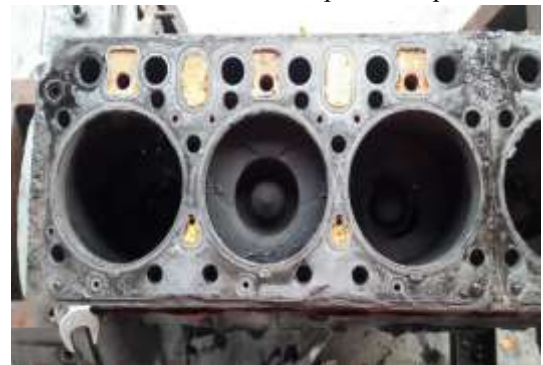
**Figure 12. Engine overheats.**

The engine experienced overheating, which may be caused by imperfect coolant circulation, suboptimal radiator performance, or malfunctioning temperature sensors. This failure often indicates insufficient thorough testing after the overhaul.

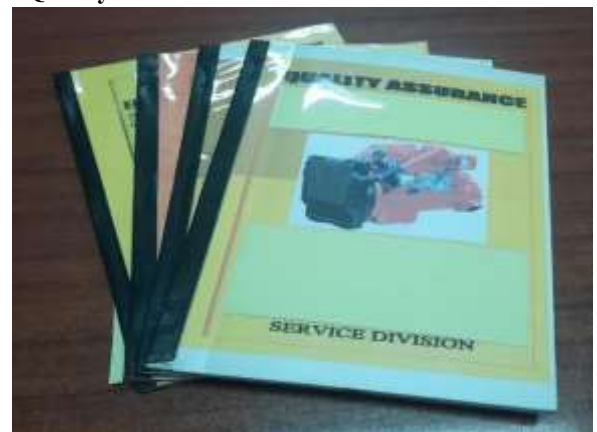
**Figure 13. Quality Assurance Book.**

Quality Assurance (QA) in the engine overhaul process is a quality control system aimed at ensuring that every stage of engine repair is carried out in accordance with established quality standards. QA covers several critical aspects; at PT. CA3, it is implemented through five stages: Receiving (QA1), Disassembly (QA2), Measurement (QA3), Assembly (QA4), and Test Performance (QA5).
