## A Quantitative Assessment of Maintenance Strategies on the Durability of Reinforced Concrete: A Comparative Case Study

**ABSTRACT:** Urban reinforced concrete structures in tropical environments are highly vulnerable to carbonation-induced deterioration, particularly when maintenance practices are neglected. This study compares the durability performance of the National Museum of Fine Arts and Manila City Hall to evaluate how proactive and reactive maintenance strategies affect structural integrity and public safety. Using a desk-based quantitative framework, the research applied the Square-Root-of-Time model derived from Fick's Second Law of Diffusion to estimate carbonation depth and deterioration progression. Occupational Safety and Health (OSH) risks were also assessed through kinetic energy modelling of potential concrete spalling debris. Results indicated that the National Museum of Fine Arts maintained a lower carbonation depth of 27.7 mm, remaining below the critical reinforcement cover limit, while Manila City Hall reached 54.4 mm, signifying active reinforcement corrosion and deterioration. Hazard analysis further showed that Manila City Hall generated a higher impact

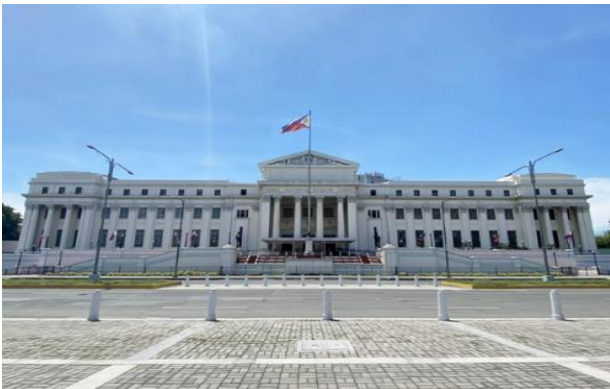
Figure 1.1 – Clean and treated facade of the National Museum of Fine Arts. Source: Google Images.

Location: Padre Burgos Avenue, Manila  
Age: 85 years old  
Use: Public Institution  
Type of Maintenance: Proactive

The engineering validity of this deterministic step relies heavily on the calibration of the K-factor to reflect historical maintenance quality. For the National Museum of Fine Arts, K was adjusted downward to 3.0 to model the proactive application of breathable, silane-siloxane hydrophobic surface barriers that successfully mitigate moisture ingress and depress the rate of carbon dioxide diffusion. Conversely, for Manila City Hall, K was back-calculated upward to 5.5 to account for the catastrophic failure of weathered acrylic coatings, which trap moisture within the alkaline matrix and accelerate the micro-cracking propagation cycle.

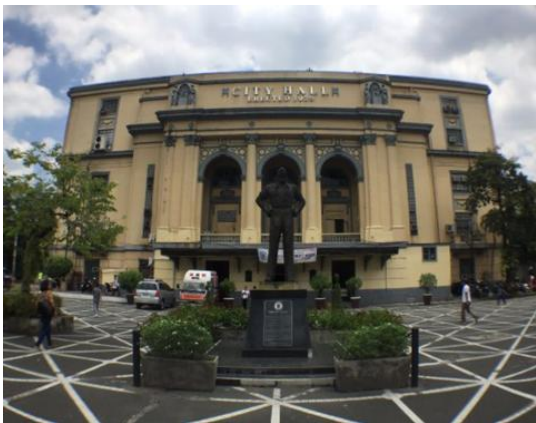
Figure 1.2 – Biological growth of the Manila City Hall. Source: Google Images.

Location: Padre Burgos Avenue, Manila

Age: 98 years old  
Use: Public Institution  
Type of Maintenance: Reactive
