Problem Solving and Rehabilitation of the Speleological Object of Larger Dimensions Which Appeared During the Excavation of the "Počitelj" Tunnel

Hrvoje Antičević, Ph.D (Mining)¹, Anita Bukovac, M.Sc.C.E.²

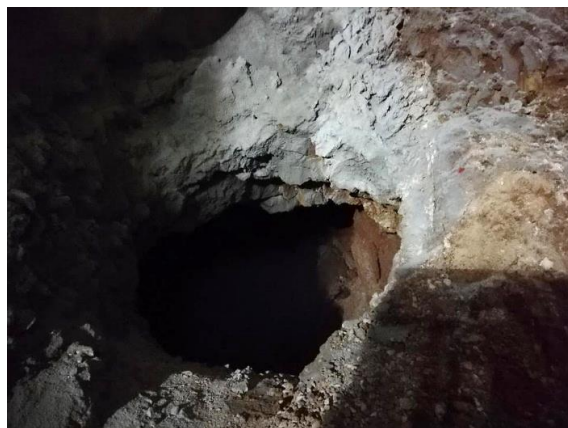
Geodetic point no. 5 on the tunnel wall was used to connect the geodetic network of the cavern with the geodetic network of the tunnel.

Entrance to the cavern. The red sign of geodetic point no. 5 is visible

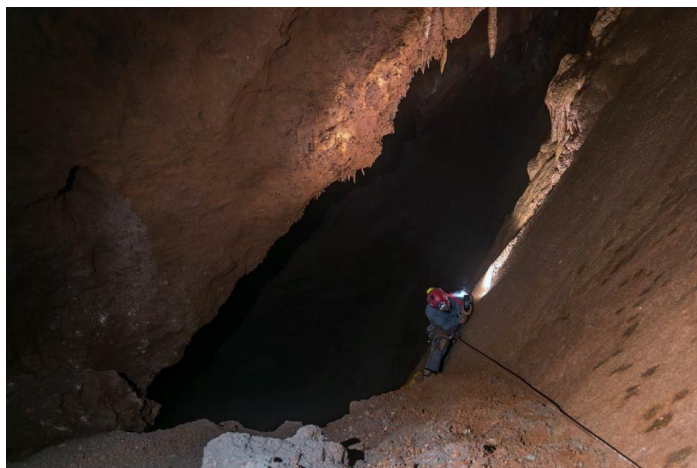
There are no speleothems except for a few stalactites above the second vertical shaft (geodetic point 2) and dry stone material found on the cave wall approximately below the stalactites. A short search for the fauna of the cave yielded no results.

Second vertical pane. The speleologist is located at geodetic point no. 2

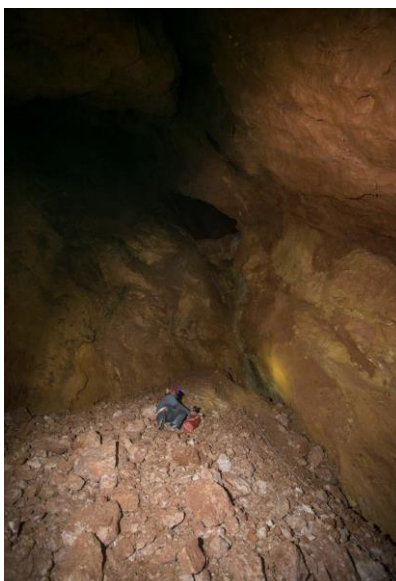
The bottom of the second shaft. The speleologist is located at geodetic point No. 1
