# The Impact of Landslides in Reclamation Areas from Stone Crusher Production Residue Materials in the Tsunami Event in the Sulawesi Earthquake on September 28, 2018

**ABSTRACT:** Sulawesi earthquake disaster followed by a tsunami on September 28, 2018 still leaves several big questions, namely the type of normal strike slip fault that rarely causes a tsunami, the very short tsunami arrival time of around 2-5 minutes and the bay area that should rarely be hit by a tsunami. Several previous studies have provided several hypotheses that the tsunami was caused by an underwater landslide or vertical deflection of the seabed due to the super shear movement. This study conducted a study of the impact of Stone Crusher factories residual production based on a field survey and supported by secondary data from previous researchers on the tsunami disaster after the strong earthquakes. The results of the field survey showed an area of around 40 Ha that collapsed on the surface, most of which was a pile area of residual Stone Crusher production on the West coast of Palu Bay. This area stretches around 20 km covering the areas of Palu City and Donggala Regency. Based on the data, there are arou

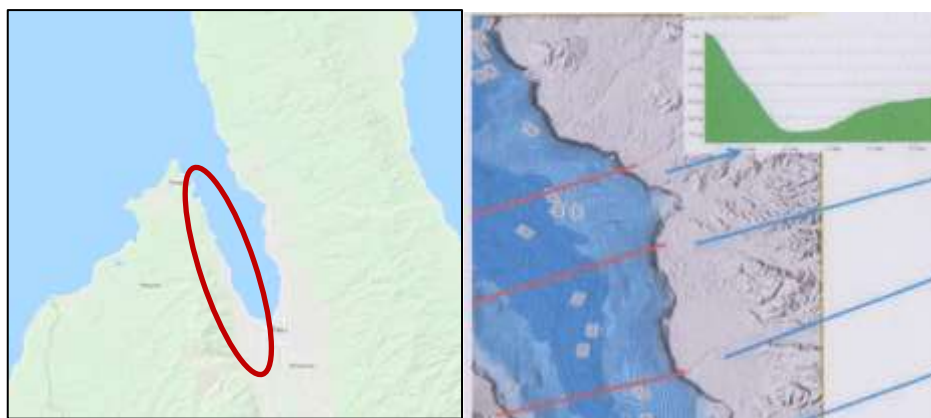
Fig 1. Map of survey locations and slope of coast affected tsunami by fill landslide Palu Bay West Coast [4]

Figure 1 shows the research location, which is on the West side of Palu Bay. The slope conditions in Palu Bay are also presented in the figure. The steeper slope of the West side than the East side causes the potential for underwater landslides due to embankments or natural cliff landslides to be more dominant on the West side. Figure 2 shows the loading activity of the stone crusher factory's production in the form of sand and split which will be sent to the Provinces of East Kalimantan and North Kalimantan on the island of Kalimantan. There are at least 11 jetty locations like this. After the earthquake accompanied by a tsunami, the condition of the shipping location like this was damaged and some of the land was lost, collapsing into the seabed. After the earthquake and tsunami, most of the jetty facilities have been
