## Evaluation of Pavement Condition and Remaining Service Life on the Guru Tua Road Section

**ABSTRACT:** The Guru Tua Road Section is a provincial road with a length of 3.96 km, serving as a connecting infrastructure between Sigi Regency and Palu City. Pavement conditions at several points are experiencing damage and causing uncertainty regarding the estimated remaining service life. This research aims to determine the condition of the road pavement to specify the type of handling, and to analyze the road's remaining service life. The evaluation of the functional condition of the road uses the International Roughness Index (IRI), Present Serviceability Index (PSI), and Surface Distress Index (SDI) methods, while the analysis of the remaining service life uses the AASHTO 1993 method. The research results indicate that the pavement condition of the Guru Tua Road Section is considered moderate, with an average IRI value of 4.595. Meanwhile, the average service function of the road is poor, with a PSI (Equation I) value of 1.205 and a PSI (Equation II) value of 1.232. Furthermore, the road pavement condition based on the average SDI value of 27.875 is good. The results of the remaini

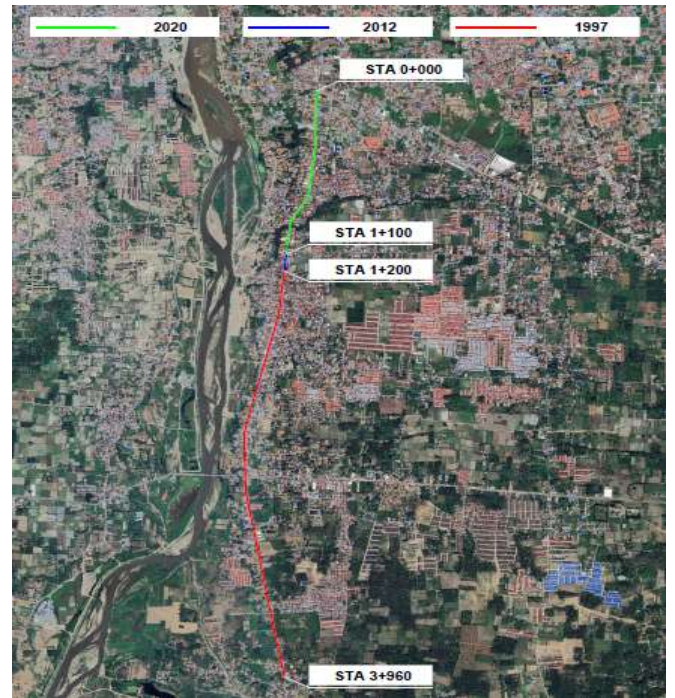
**Figure 3. History of Maintenance on Guru Tua Road**

Based on the figure 3, the segment from STA 0+000 to STA 1+200 is well-maintained, having undergone rehabilitation in 2012, followed by an overlay on STA 0+000 to STA 1+100 in 2020 using Asphalt Concrete-Wearing Course (AC-WC), reflecting a commitment to preventive maintenance on the initial segment. In contrast, the segment from STA 1+200 to STA 3+960 was last treated in 1997 with a Hot Rolled Sheet (HRS) pavement, indicating a lack of significant maintenance for over two decades. This suggests that the segment from STA 1+100 to STA 3+960 has exceeded its pavement service life. In this study, an analysis was conducted to assess the pavement condition using the International Roughness Index (IRI), Present Serviceability Index (PSI), and Surface Distress Index (SDI). Based on the IRI and SDI values, the appropriate type of pavement treatment was determined. Additionally, a remaining service life analysis was performed to estimate the year in which the treatment would be required.

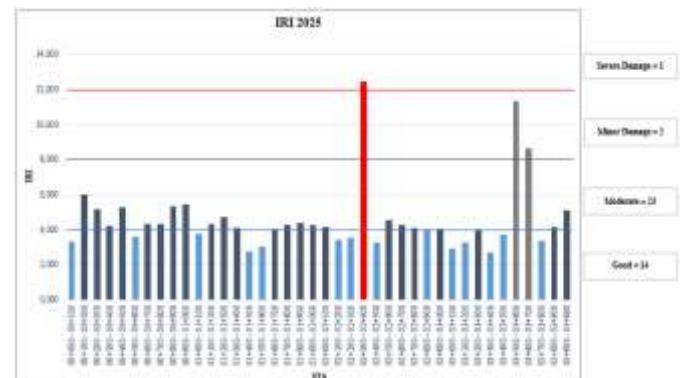
**Figure 4. IRI Values of the Guru Tua Road Section**

The pavement condition analysis based on IRI values shows varying conditions, with 14 segments classified as good, 23 segments as fair, 2 segments as lightly distressed, and 1 segment as severely distressed. The severely distressed segment, identified by very high IRI values between STA 02+300 and STA 02+400, indicates significant discomfort and potential hazards for road users. The severely distressed pavement condition is illustrated in Figure 5.

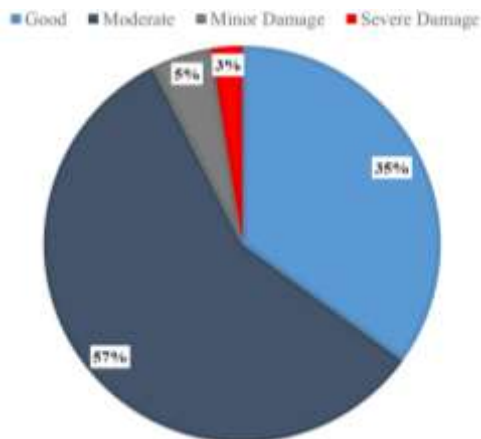
Figure 6. Percentage of Road Conditions Based on IRI Values

Based on IRI values, the condition of the Guru Tua Road section is classified into Good, Moderate, Minor Damage, and Severe Damage categories. The analysis shows that 35% of the road falls under the Good category, indicating that approximately one-third of the road section remains suitable for use without major maintenance. The Moderate category has the largest proportion at 57%, suggesting that most of the road is beginning to experience quality deterioration. Meanwhile, the Minor Damage category accounts for 5%, indicating a small portion of the road exhibiting surface distresses such as cracks or potholes that require prompt repair. Although the Severe Damage category represents only 3%, it is critical because segments in this category require rehabilitation or reconstruction to ensure road user safety and comfort.

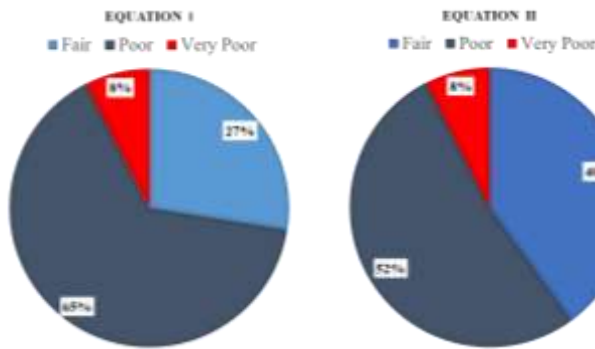
Figure 7. Percentage of Level of Service

Based on the analysis using the PSI method with Equation I, out of a total of 40 segments analyzed, 11 segments were classified as having a fair level of service, accounting for 27%, while 26 segments fell into the poor category, representing 65%, and 3 segments were classified as very poor, representing 8%. Meanwhile, based on the analysis using the PSI method with Equation II, 16 segments (40%) were classified as fair, 21 segments (52%) as poor, and 3 segments (8%) as very poor in terms of road service level.

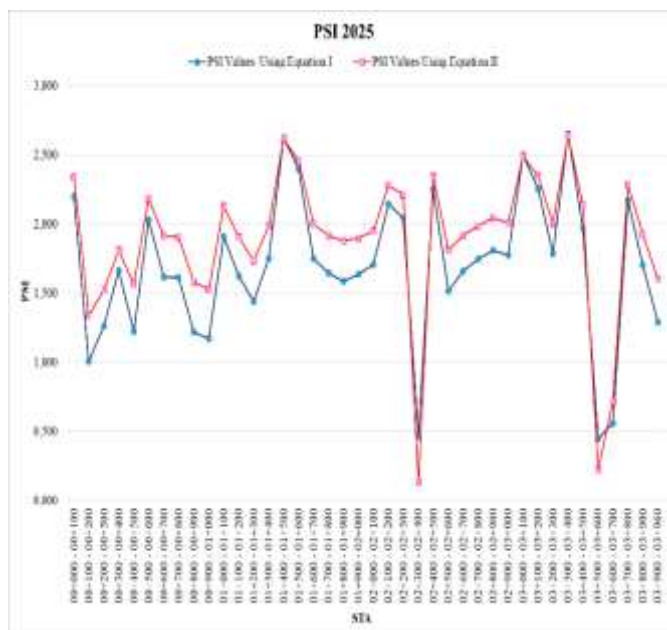
Figure 8. Level of Service Based on Equations I and II

Overall, the condition of the Guru Tua road section indicates that it has not yet provided an optimal level of service to users. The highest PSI value only reached approximately 2.5 on a scale of 5, indicating that the service level is still moderate to poor. More critical conditions were observed at two critical points, namely STA 02+400–02+500 and STA 03+600–03+700, where the PSI values dropped close to 0.

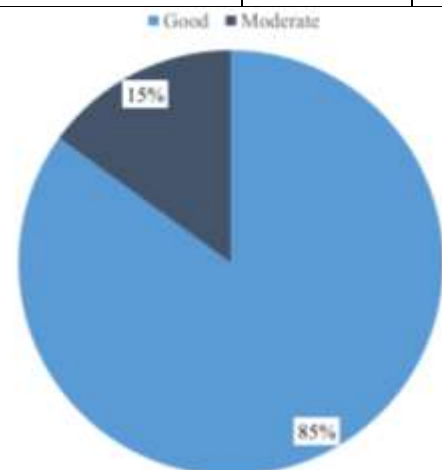
**Figure 9. Percentage of Road Condition Based on SDI Values**

The analysis of the pavement condition of the Guru Tua road using the Surface Distress Index (SDI) method indicates that the condition varies across segments, although overall it remains generally in good to fair condition. Based on the SDI

calculations, approximately 85% of the segments fall into the good category, indicating that the majority of the pavement surface is still serviceable and does not require major maintenance. However, around 15% of the segments are classified as fair, suggesting the onset of surface distresses such as cracks and potholes that may affect the comfort and safety of road users.

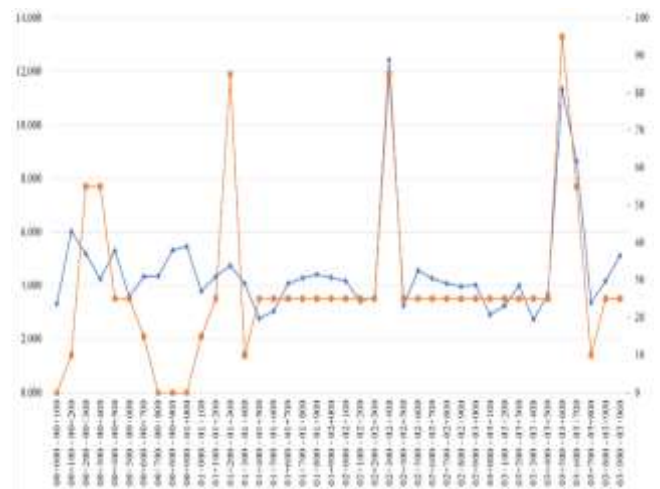
**Figure 10. International Roughness Index (IRI) and Surface Distress Index (SDI) Values**

The combined analysis of IRI and SDI values reveals significant variation in pavement conditions along the Guru Tua Road. The highest IRI value (12.439) was observed at STA 02+300–02+400, indicating very poor ride quality, accompanied by a high SDI value (85) that reflects severe surface distress. Meanwhile, the highest SDI value (95) occurred at STA 03+500–03+600, indicating more severe surface damage, with the IRI value (11.344) also classified as lightly damaged. Overall, the worst pavement conditions were identified at STA 02+300–02+400 and STA 03+500–03+600, as indicated by the consistently high IRI and SDI values at these segments.

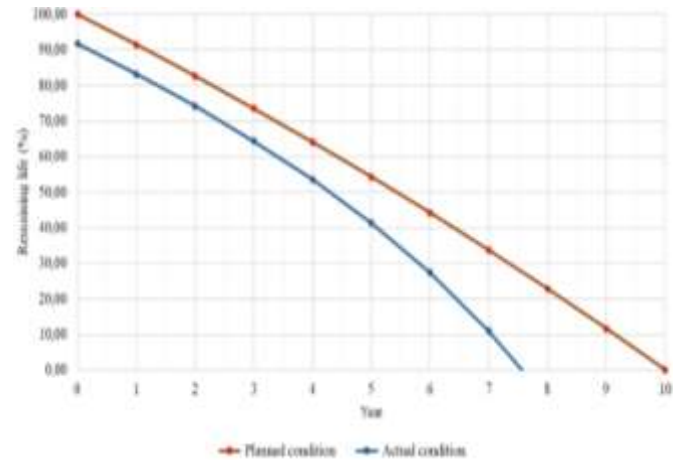
**Figure 12. Remaining Service Life of the Pavement**

The Remaining Service Life graph of the Guru Tua Road illustrates a comparison between the design condition (red line) and the actual condition (blue line) over a 10-year period. The red line represents the initial design prediction in accordance with MDPJ 2024, in which the remaining service life decreases uniformly and reaches 0% at the end of the tenth year. In contrast, the blue line reflects actual field conditions, where the pavement reaches 0% remaining service life at approximately the beginning of the eighth year, with a reduction of 22.72%. This indicates that the service life of the Guru Tua Road is exhausted earlier than planned, resulting in an estimated reduction of about two years compared to the design life. These findings highlight the need for greater attention to discrepancies between design assumptions and real-world conditions, as well as the importance of implementing timely and well-planned maintenance strategies to ensure that the pavement achieves the intended 10-year service life in accordance with MDPJ 2024.
