Strengthened of Wooden Trusses Structure and Retrofitting Methods to Increase Load Capacity

ABSTRACT: Assessing after the strong earthquake, several wooden truss structures were damaged. The damage varies from dislocation of the truss mounts with their supports, displacement between the curtain rods and truss frames as well as damage to the truss joints themselves. This research will study the types of damage, causes and methods of strengthening and repairing element of roof truss and frame that were damaged after a strong earthquake based on the level of damage, method and materials suitable for implementation. Data on the damage to the truss structure described were obtained from field assessments as well as secondary data from earthquake events from various regions in Indonesia and other parts of the world and segmental testing of truss. Failed in tension, compression, shear and support were found due to insufficiency of connecting devices and incomplete configuration of truss elements. The age factor and the wood material preservation system also cause the level of damage to the frames of these horses to be higher. Conventional strengthening methods using wood, iron, stainless

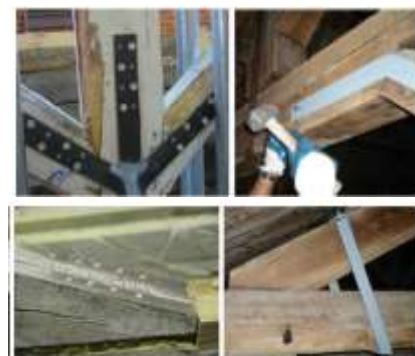
Figure 2. Various types of steel plate-based roof frame reinforcement (Branco et al., 2018)

Types of double and triple grip jointers to strengthen connections are commonly used between beam elements and wooden structural floor plates. Meanwhile, tooth plate connecting tools are used in connections between truss frame elements. Strengthening connections between columns and beams or between beams uses special plates and bolts

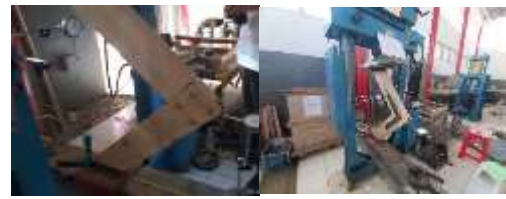
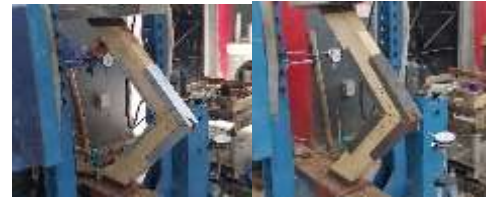
Figure 9. Setting up of all specimen

60.4 strip plate. The model of the test specimen is illustrated in Figure 9.

Weak location from wooden roof frame located at the Roof to Walls Connection and the top frame the roof (Stevenson et al., 2019). The weakness points of wooden roof trusses consist on peak and supported of the truss. Based to this study, retrofitting of the segmental wooden roof truss done with L35.35.3, 70.35.0.45 stainless steel and 60.4 strip plate.
